Navajo Abandoned Uranium Mine

Site Screen Report

Mine Name: Elwood Canyon No. 1
Mine ID: 129

August 2011

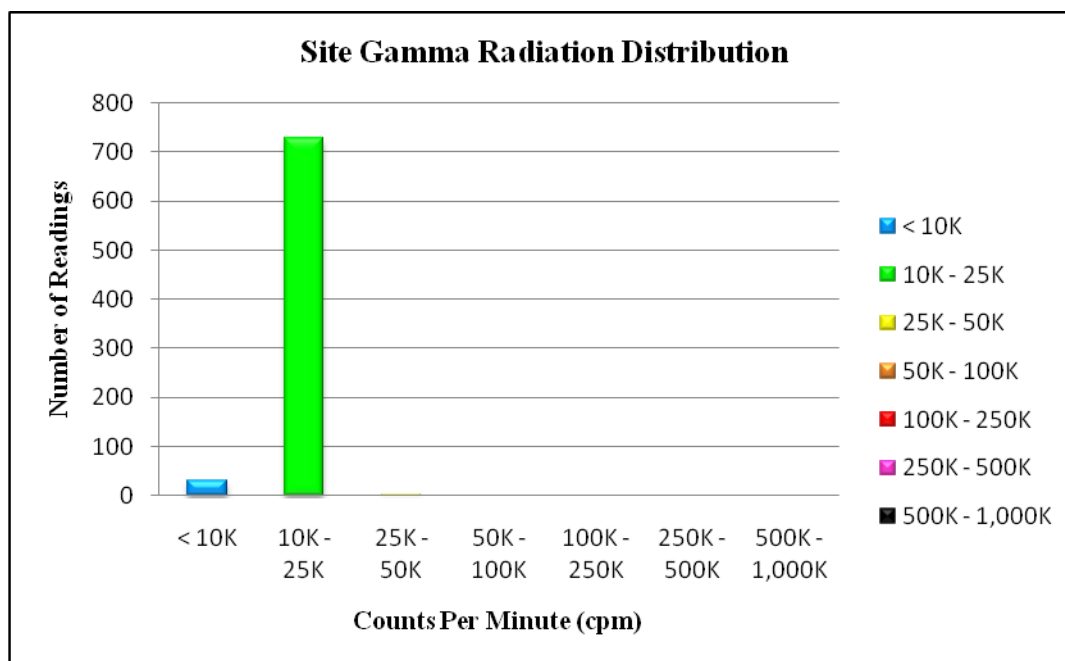
Distribution Chart and Statistics:

Site Gamma Radiation Statistics

Number of Readings	761
Minimum (cpm)	7,462
Maximum (cpm)	27,821
Mean (cpm)	14,595
Median (cpm)	14,553
Standard Deviation	1,935

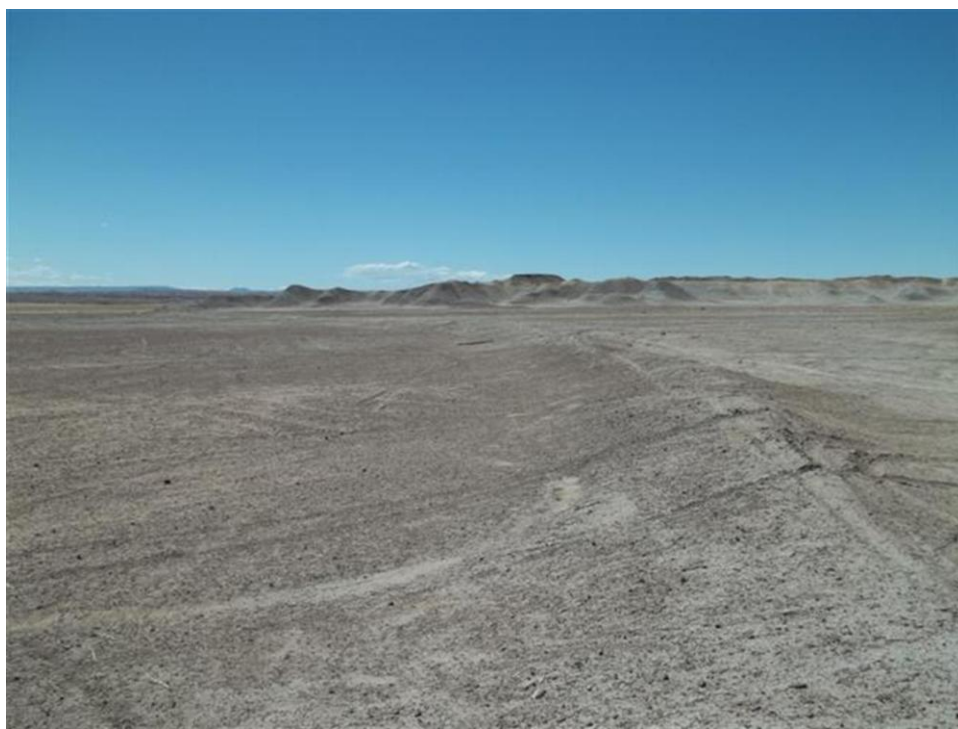
Photo 2: Mine Site #129; Berm area

Berm around north side of site

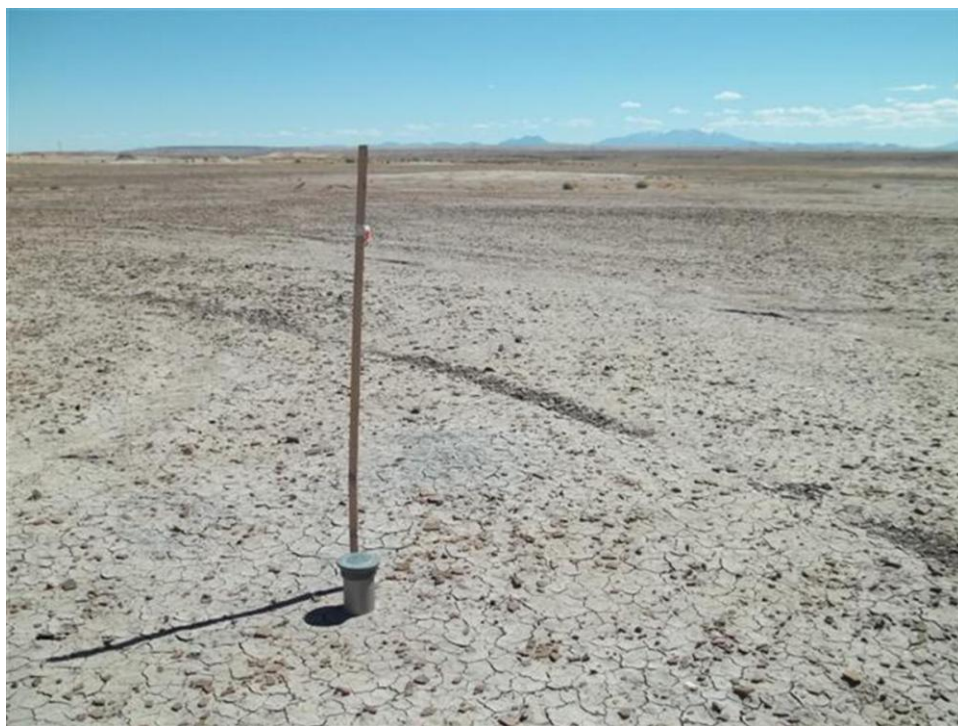
Photo 3: Mine Site #129; Survey marker

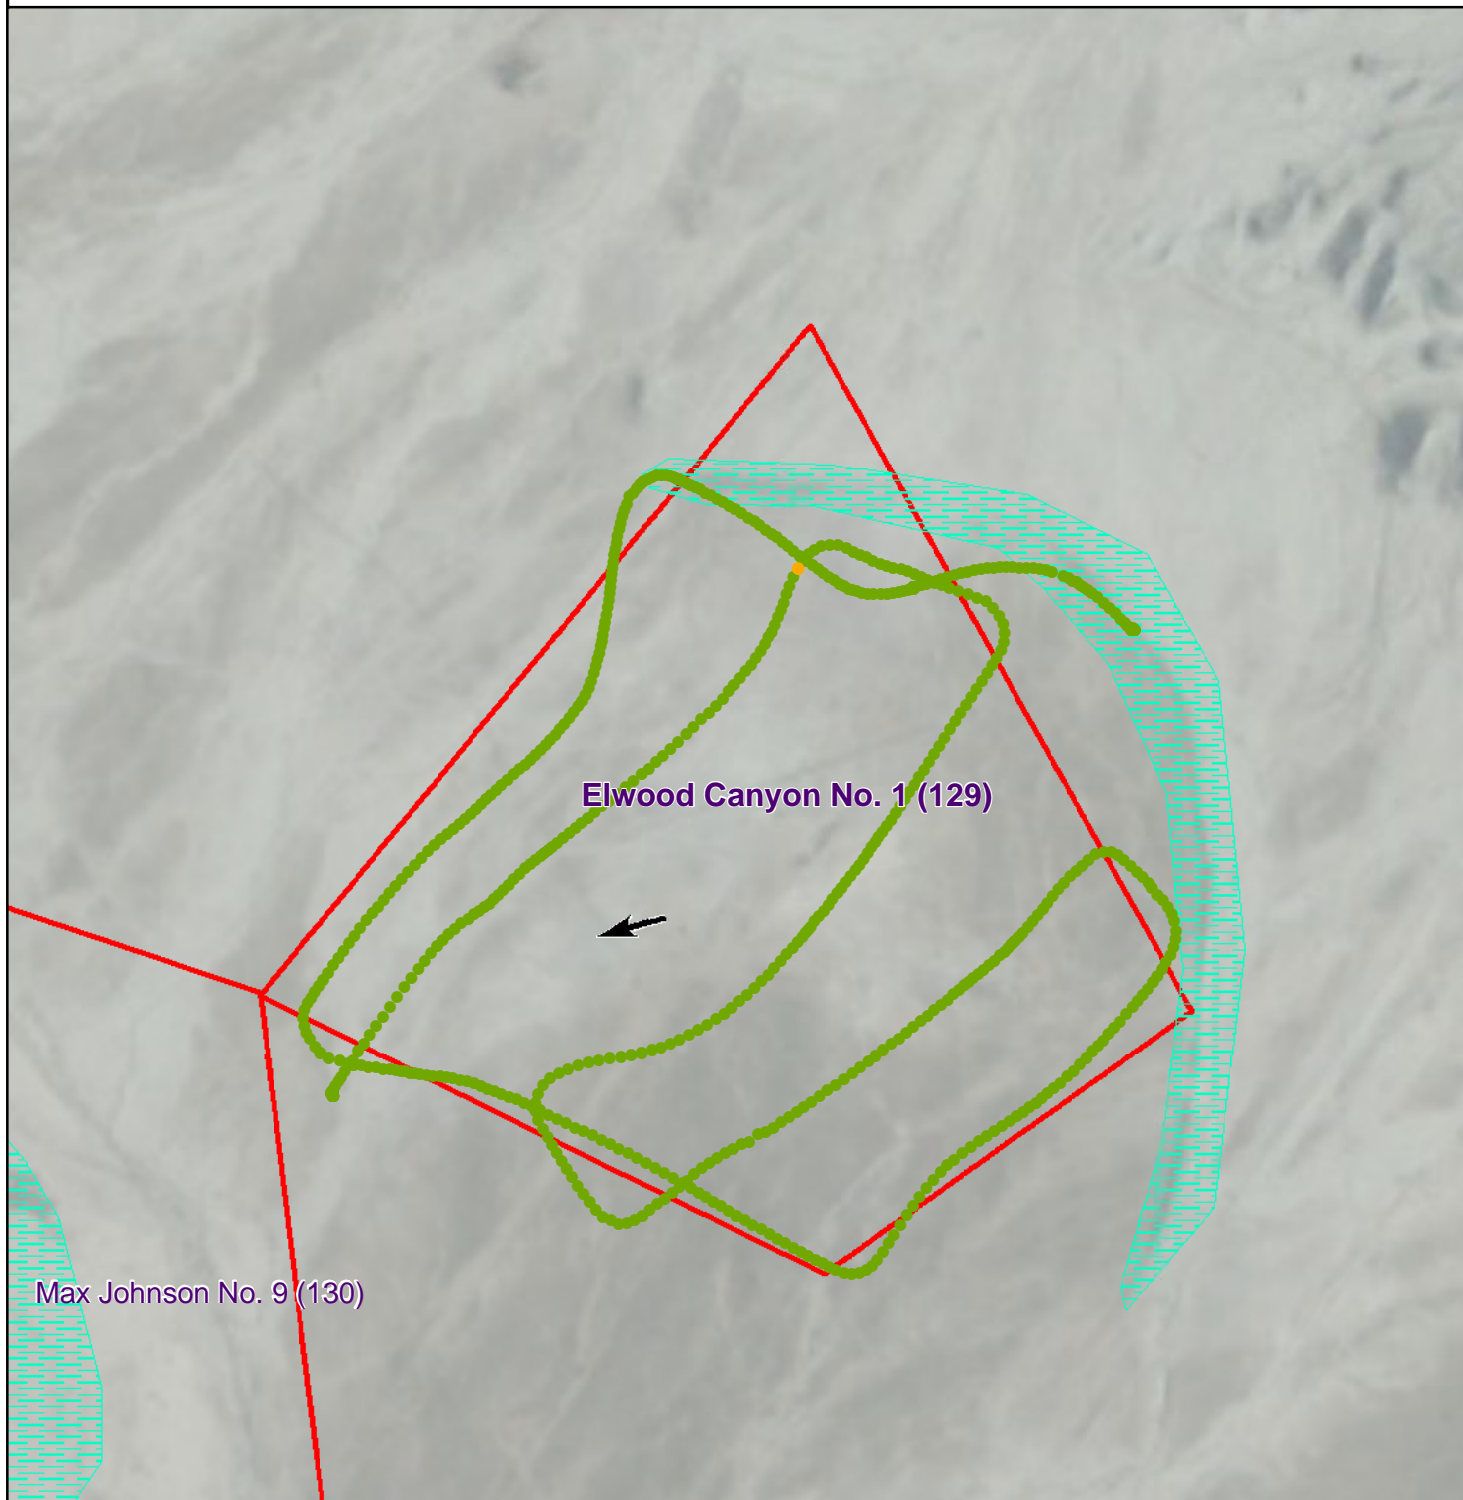
**Figure 1 - Gamma Radiation Measurements, Above Two Times Background
Elwood Canyon No. 1 (129)
Coalmine Mesa Chapter, Navajo Nation**

Average background 13,535 cpm

A total of 761 gamma radiation measurements were collected from the mine site, ranging from 7,462 cpm to 27,821 cpm. The measurements are represented in Figures 1 and 2.

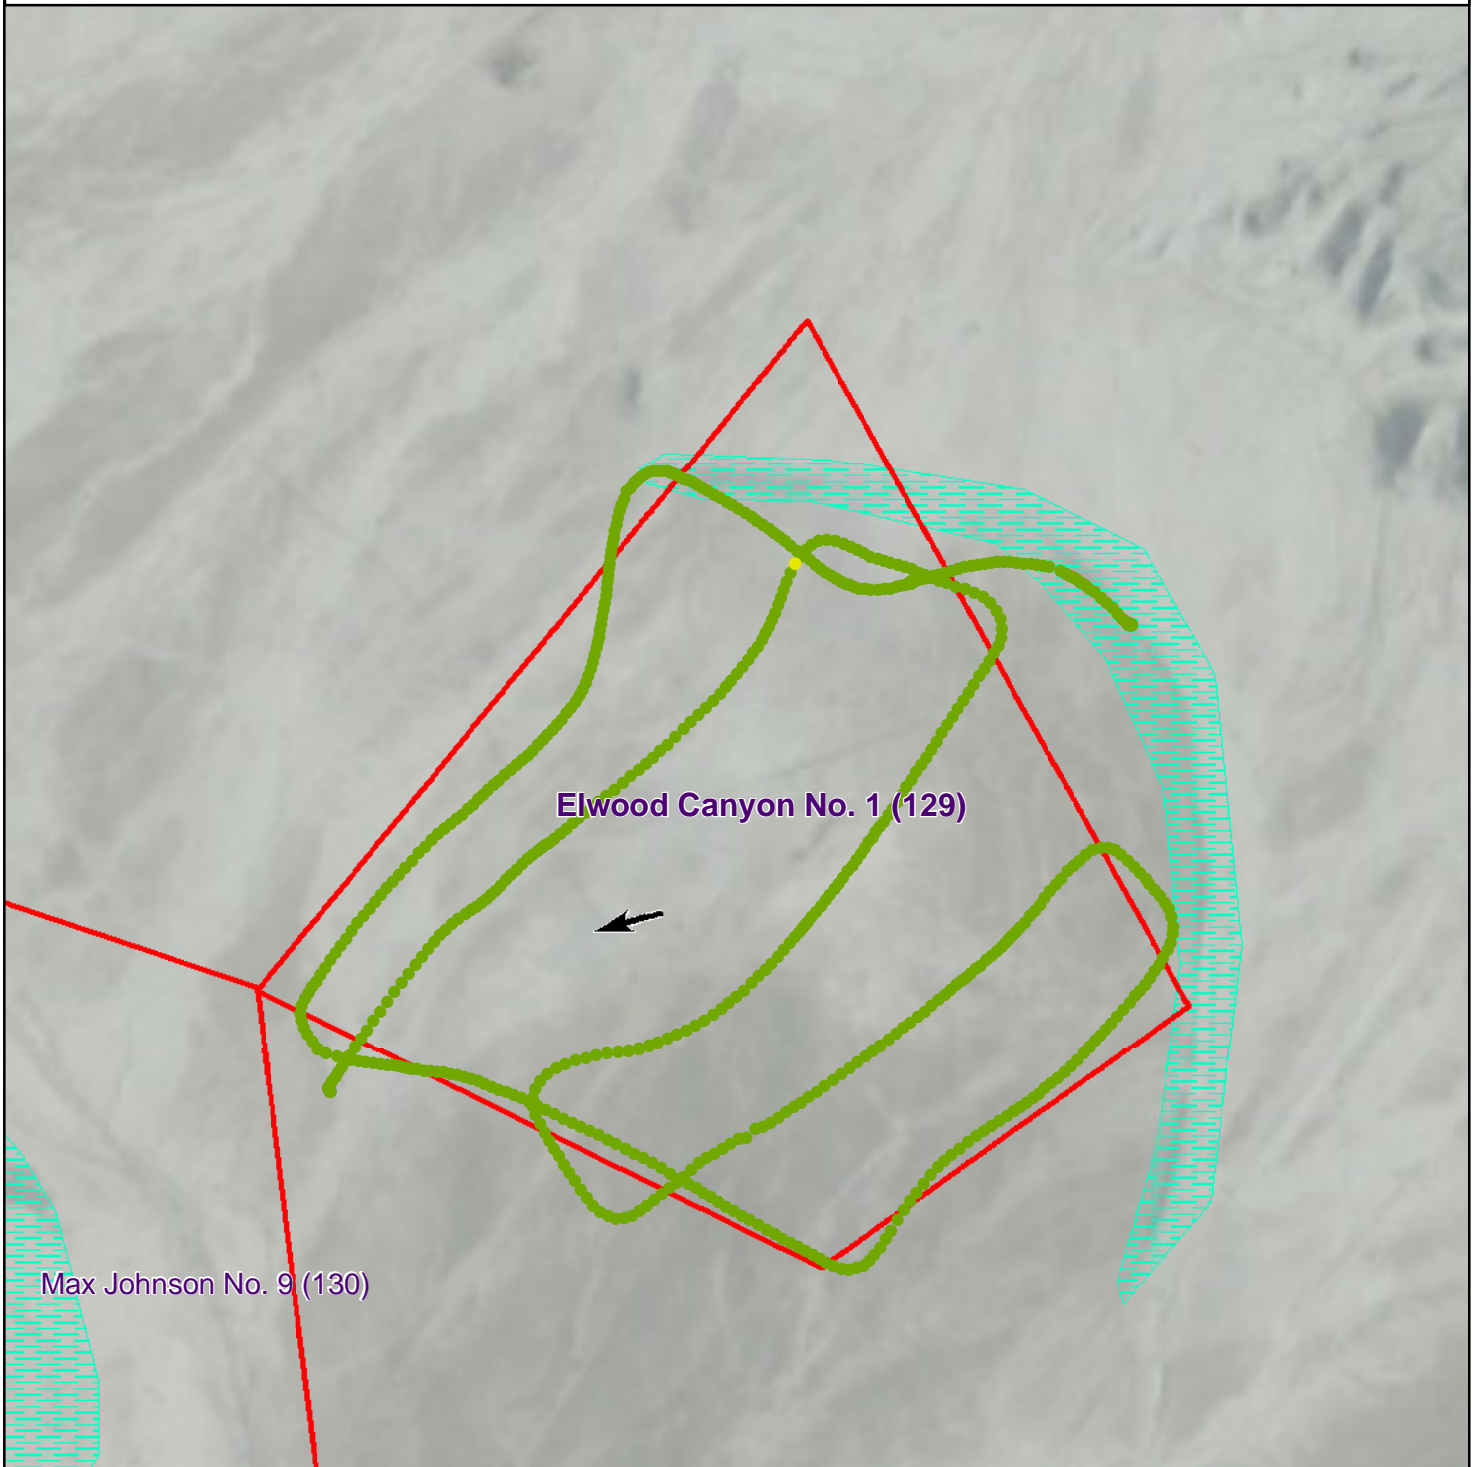
**Figure 2 - Gamma Radiation Measurements
Elwood Canyon No. 1 (129)
Coalmine Mesa Chapter, Navajo Nation**

Measured as counts per minute (cpm) Average background 13,535 cpm
